BERKELEY ENGINEERING AND RESEARCH INC

Expert Report

Wadsworth v. Jetson et al

July 12, 2024

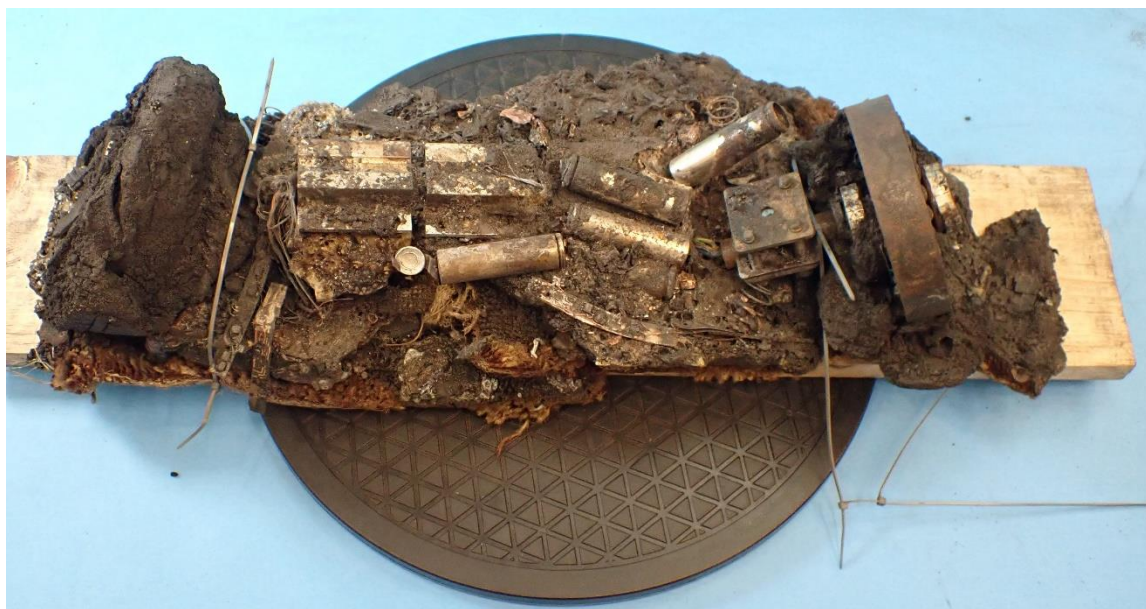
Figure 1: The remnants of the subject Jetson hoverboard.

Detailed examination of the subject board shows that two out of ten cells exploded while the other eight cells show heat damage. Exploding cells are consistent with an internal short, thermal runaway, and vaporization and ignition of the liquid electrolyte.

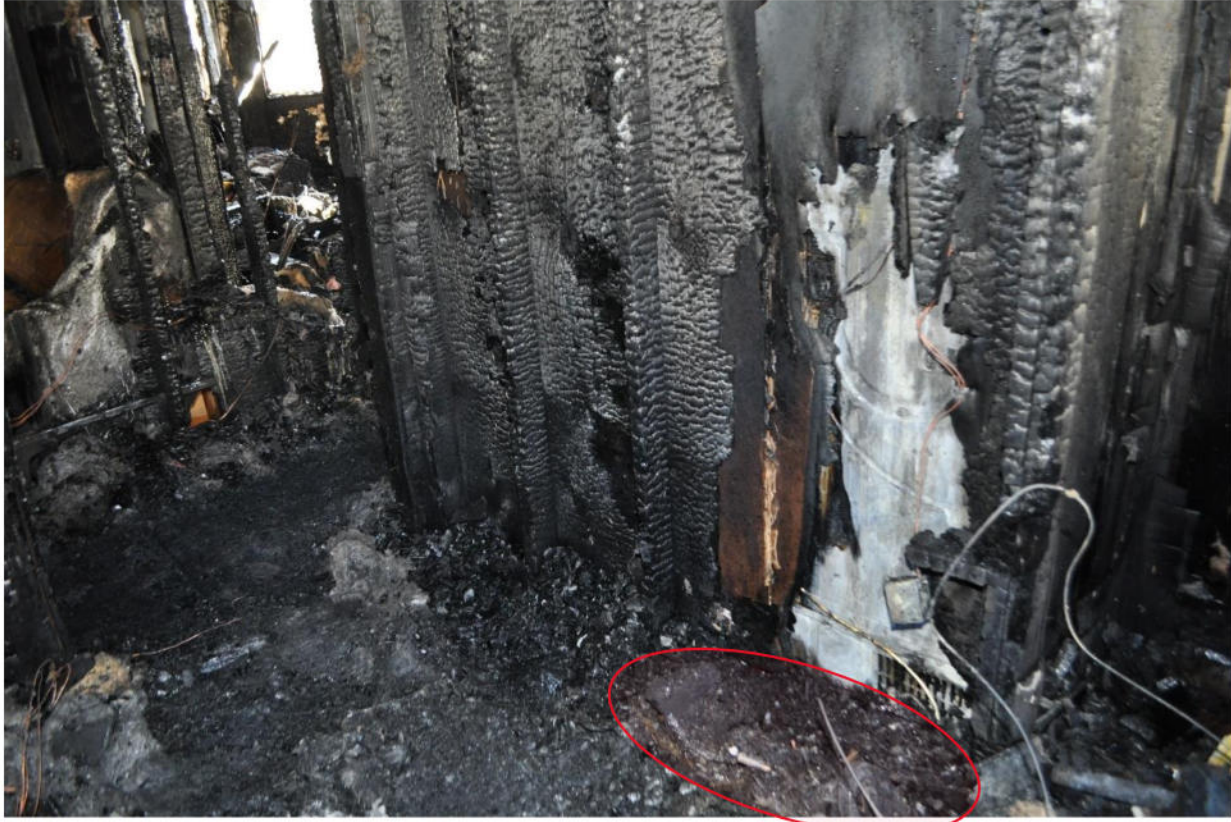
Figure 4: The general location of where the wall V-pattern points. The wall above the subject board (circled) is completely burned away.

- An exterior fire would have to rise along the wall, enter through the eaves, and then burn down to eventually reach the subject board. The exterior wall should therefore be exposed to the fire for the longest duration.
- The exterior of the house at and around the window area is substantially less fire damaged than the interior. The exterior wall studs are largely intact. This suggests a shorter and less intense exposure to fire on the outer wall compared to the interior.
- Detective Sheaman observed an interior V-pattern which included studs which were nearly completely consumed by the fire.

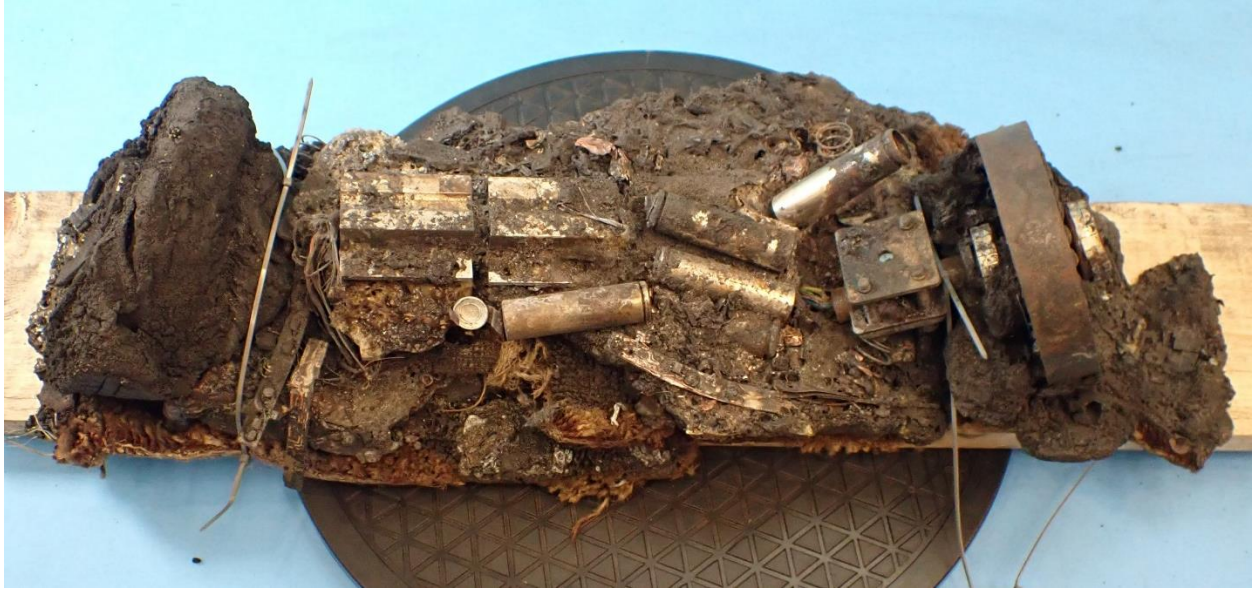
Figure 5: The subject board as-received by BEAR. The wood plank appears to be added for physical support of the loose evidence.

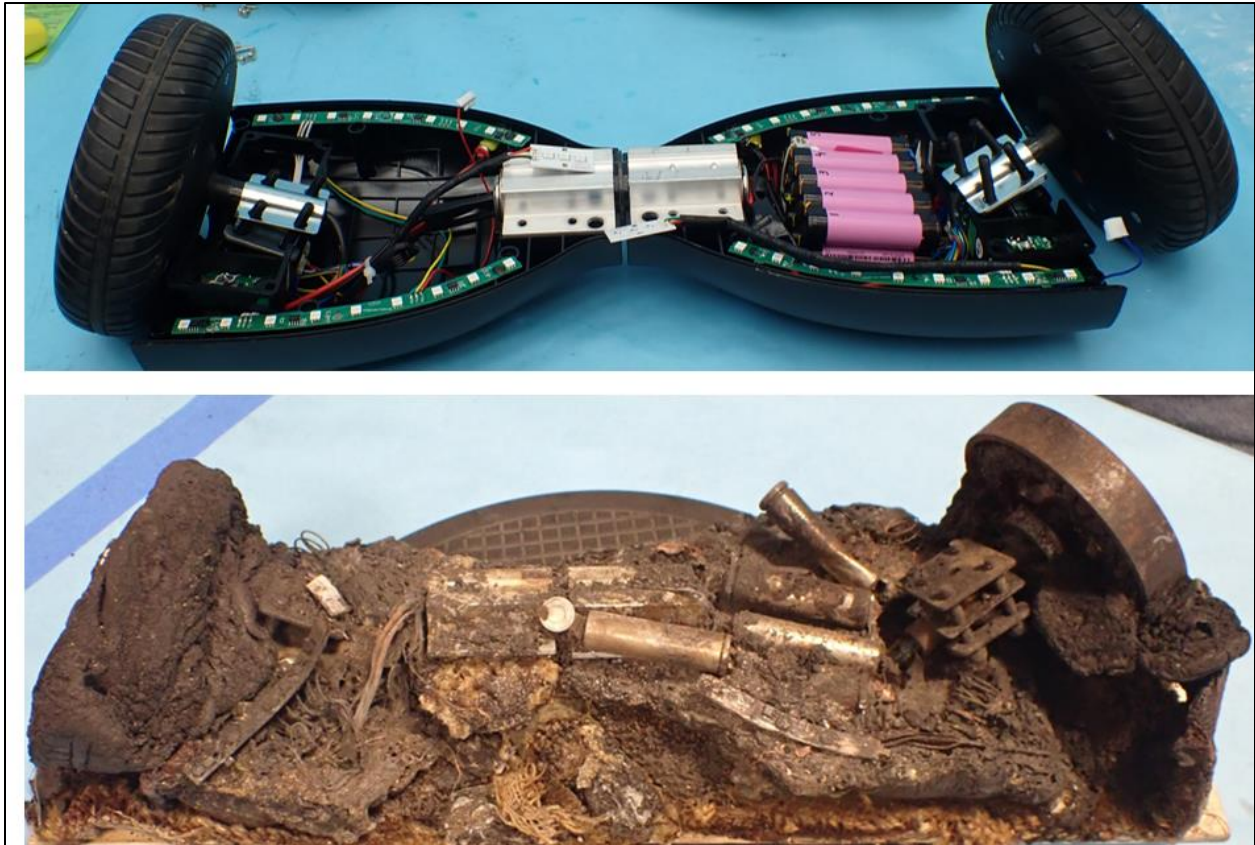
Figure 6: An exemplar board disassembled and oriented approximately the same as the evidence.

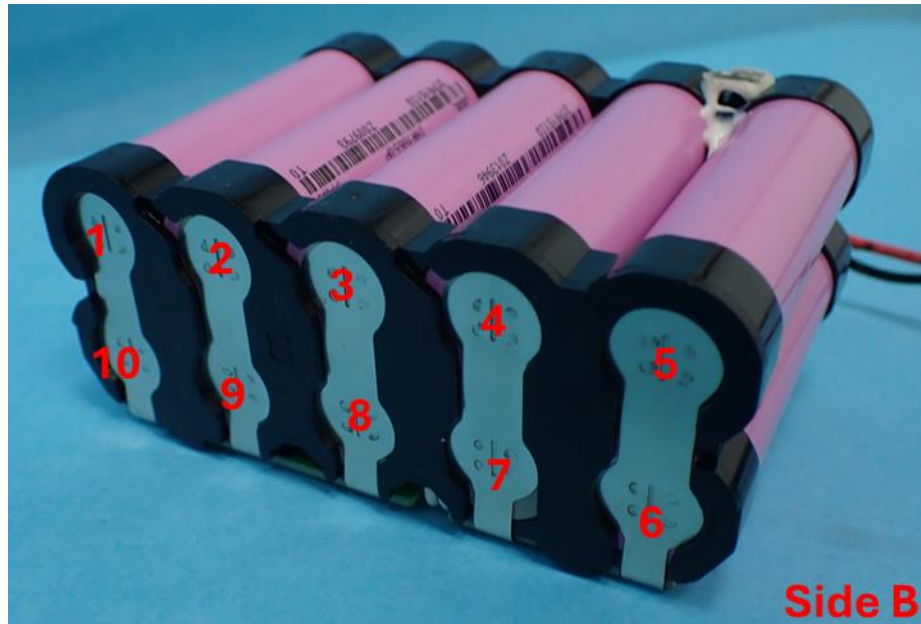
Figure 8: The other side of the exemplar battery pack with cells numbered for positional reference.

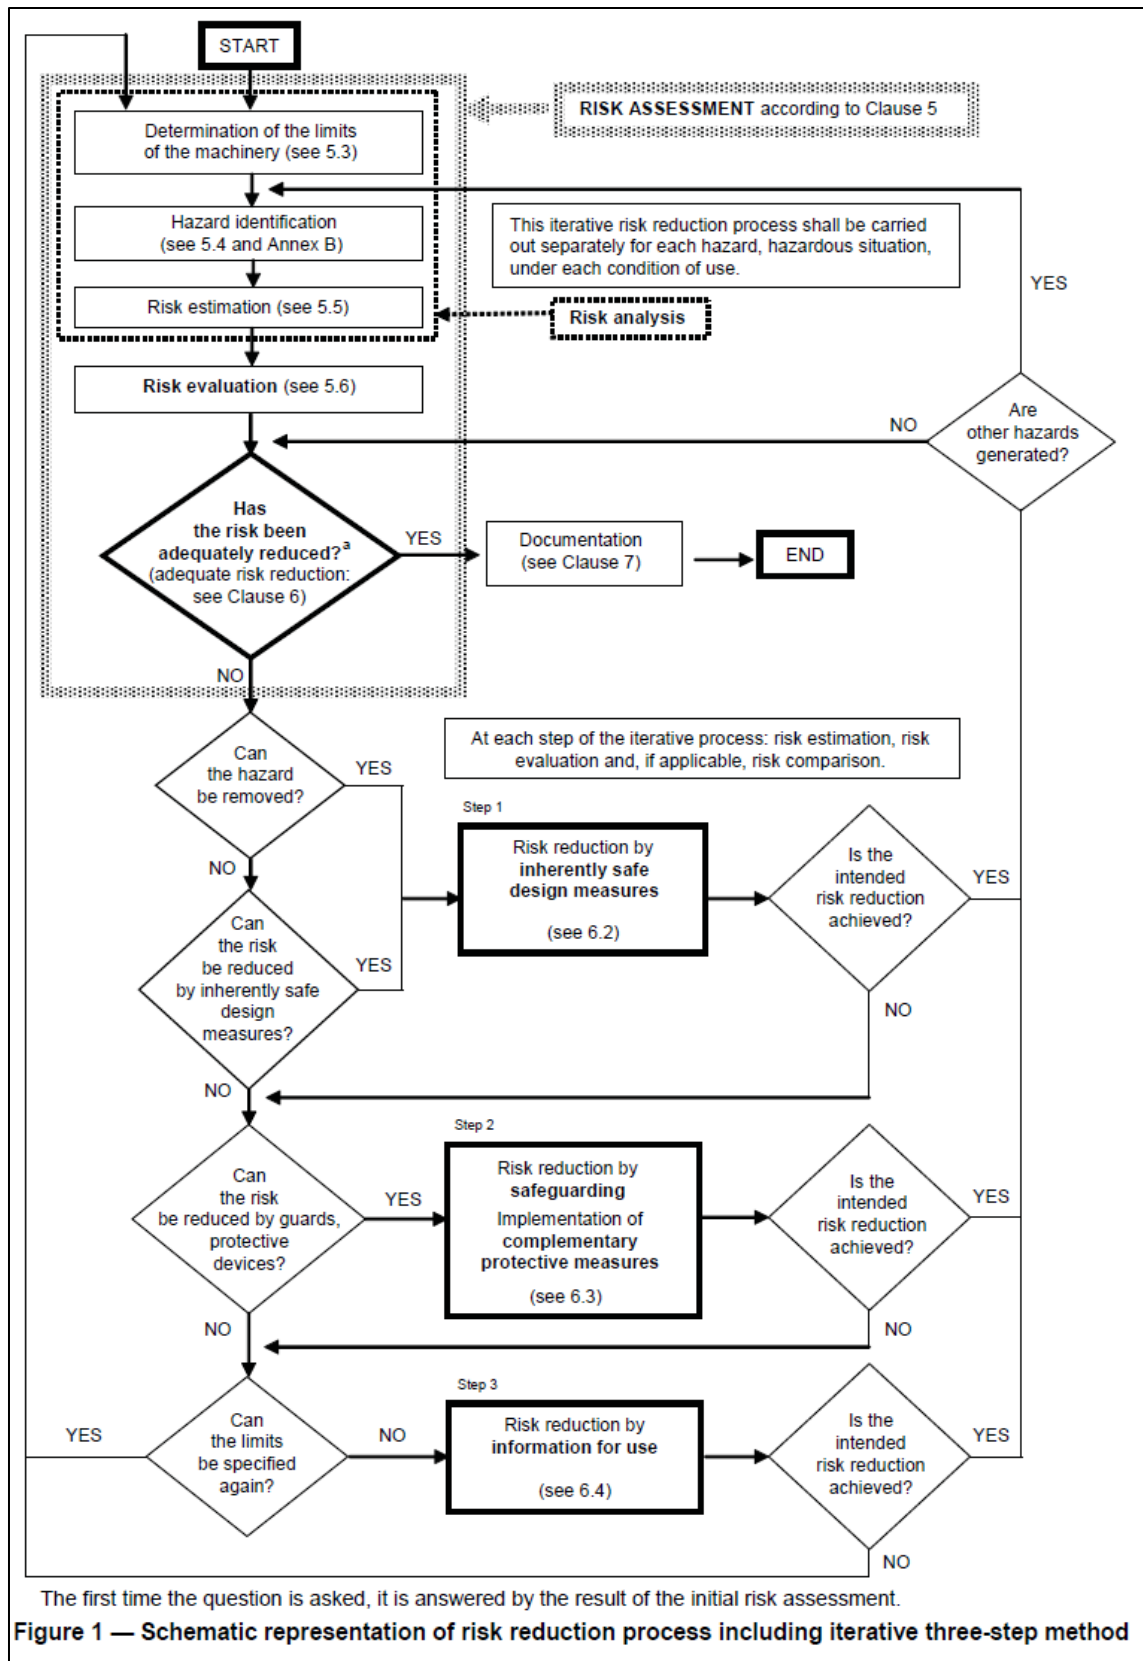
This concept of first mitigating the hazard through design, then if that cannot be accomplished to mitigate through guarding, and only then if those both cannot be accomplished to mitigate via information has been formalized in the ISO Standard 12100 for machine design, and it shown in **Figure 10** below:

Figure 10: From ISO 12100, a risk assessment flow chart.

Jetson should have conducted an FMEA or other Risk Assessment to eliminate unnecessary risks as part of their design process.
